AMERICAN NAVION SOCIETY, LTD.

FIELD SERVICE BULLETIN 101

TO: All Riley & Temco D-16 & D-16A Twin Navion owners

SUBJECT: Nose Gear Fork Inspection

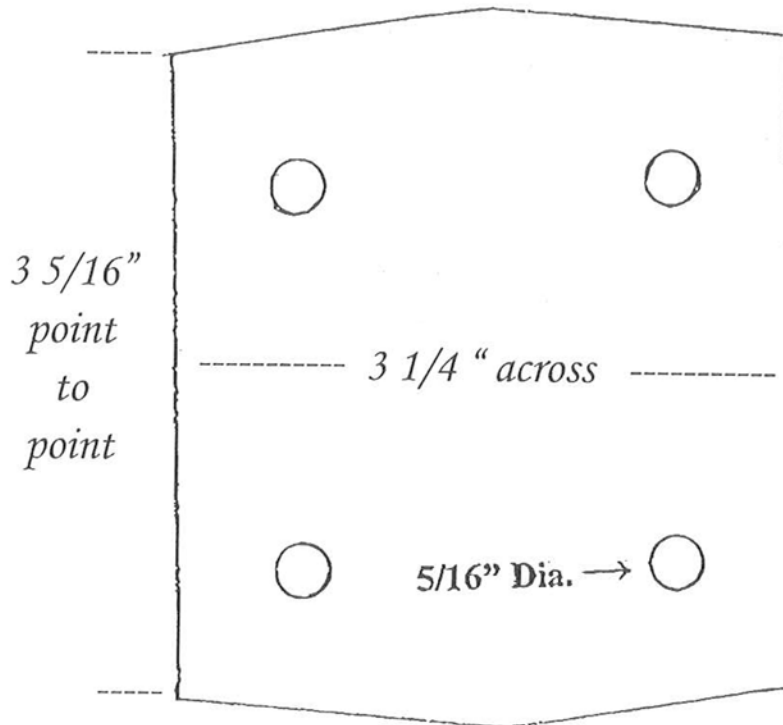
DRAWING A
PLATE 145-34117-1003

A failure issue with the Navion nose gear fork, part no. 145-34117 has been detected and necessitates action by all Navion owners. Two forks have failed at the four attach point holes resulting in substantial damage to the engine, propeller, and airframe. At one repair facility twenty (20) nose forks were removed and inspected by the dye penetrant method and four (4) had cracks. A significant percentage of the failed or cracked forks were from Navions with prior history of a nose gear collapse and ground contact, which would have placed an aft force on the fork through the nose gear tire and wheel which protrudes below the wheel well when retracted.

thickness of plate. Reinforcement plate spreads load of bolt heads over a much larger area of the fork than the AN960-5 washers. The plate is a preventative repair measure and not a repair for a cracked fork.

- 1. Reinstall fork with 145-34117-1002 reinforcement plate on underside of fork. Lateral edges of plate may have to contoured to fit contour of the nose fork. Install new longer AN bolts to compensate for**

3. Plate 145-34117-1002 specifications are shown in Drawing A.

**Contour upper surface of plate to mate
with contoured surface of fork**

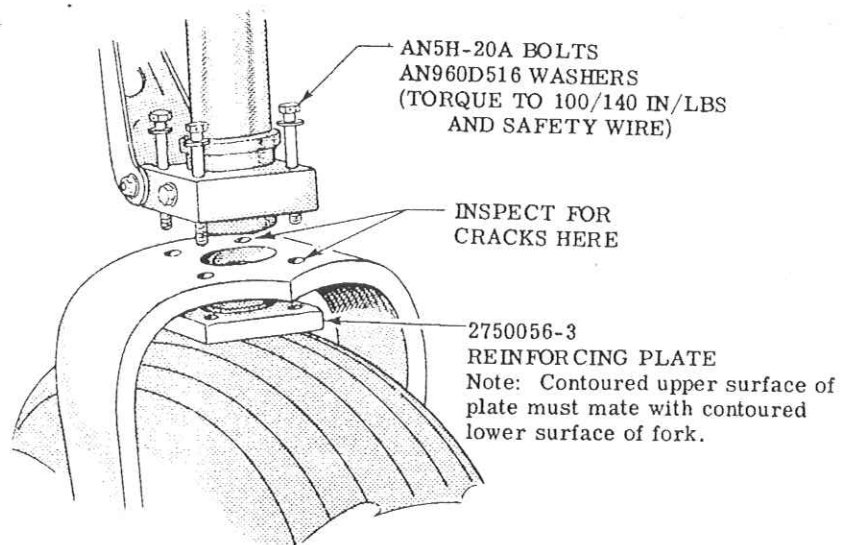
FIG. 1

PURPOSE: To provide inspection procedure and maintenance information to owners and operators of Model 520 and 560 Aero Commanders equipped with the Ryan Nose Landing Gear. Service reports indicate that cracking and elongation may occur in and around the nose gear fork attach bolt holes. A reinforcing plate has been designed by Aero Design & Engineering Co., and may be purchased through any Aero Commander Distributor. The list price of this plate and the necessary attaching hardware is \$13.96. The purpose of the plate is to distribute the clamping load over a larger area, thereby relieving the bearing loads under the attach bolt heads.

- d. If the fork is deemed serviceable or a new fork is being installed, the retaining bolts and nuts should be torqued to a value of 100/140 in/lbs. It is recommended that the original AN365-524 fork retainer nuts be replaced. In the event the new 2750056-3 plate is being installed the same torque value will apply and the plate should be installed as shown in Figure I.
